Appendix: Photos of Scored Coupons

Isabella Buscarino 3/7/2018

This photo library shows photos of scored lead coupons that were aged 28 days in the Met’s current Oddy test system (Method: 20171116_OT). This method involves the hanging of coupons from laser sintered nylon holders. The coupons are unfolded and flattened for scoring and photographing. Photographs of the coupons are taken separately with two different light sources—one is a diffuse lighting meant to distinguish colors and the other is a glancing angle light source meant to pick-up on surface textures. The light source techniques are abbreviated as “Si” for diffuse light and “GA” for glancing angle light. See table below for a key. “GA” photos are only displayed if they show more detail than “Si” photos. Coupon photos are labelled with the abbreviation of the light source that was used to capture the photo. If a glancing-angle-photo appears, it is shown next to its corresponding diffuse-lighting-photo.

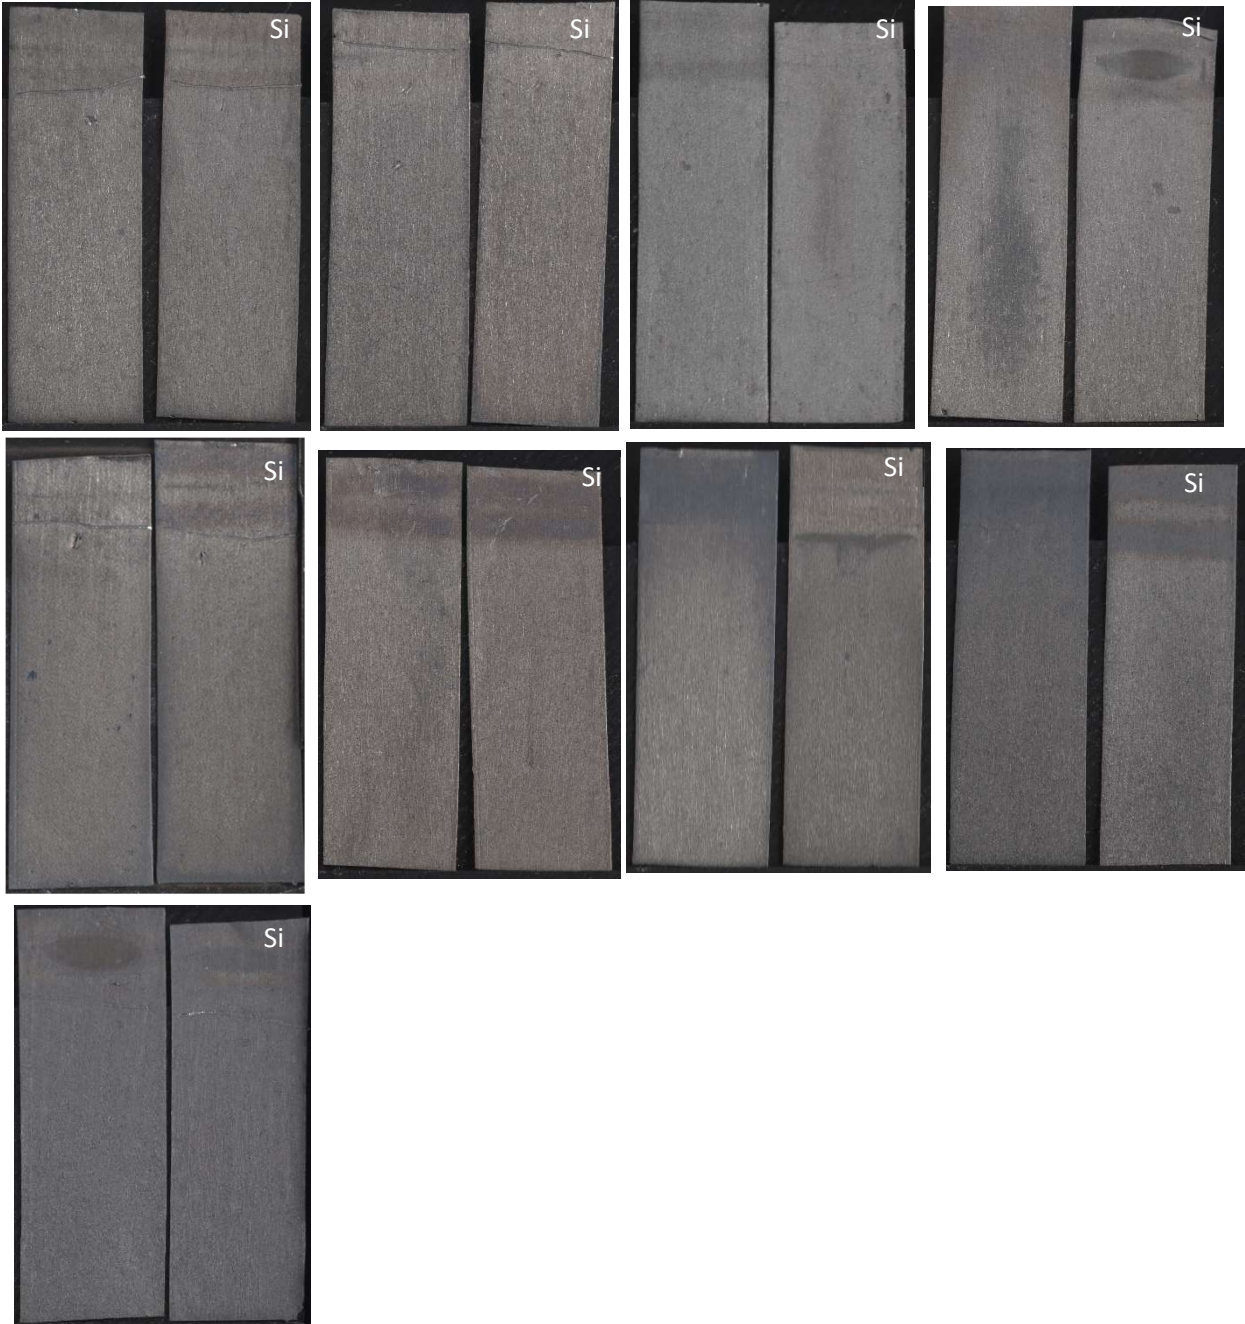
Permanent

“Permanent” rating: The material tested may be used indefinitely in the presence of art.

- Coupons look similar to the controls.

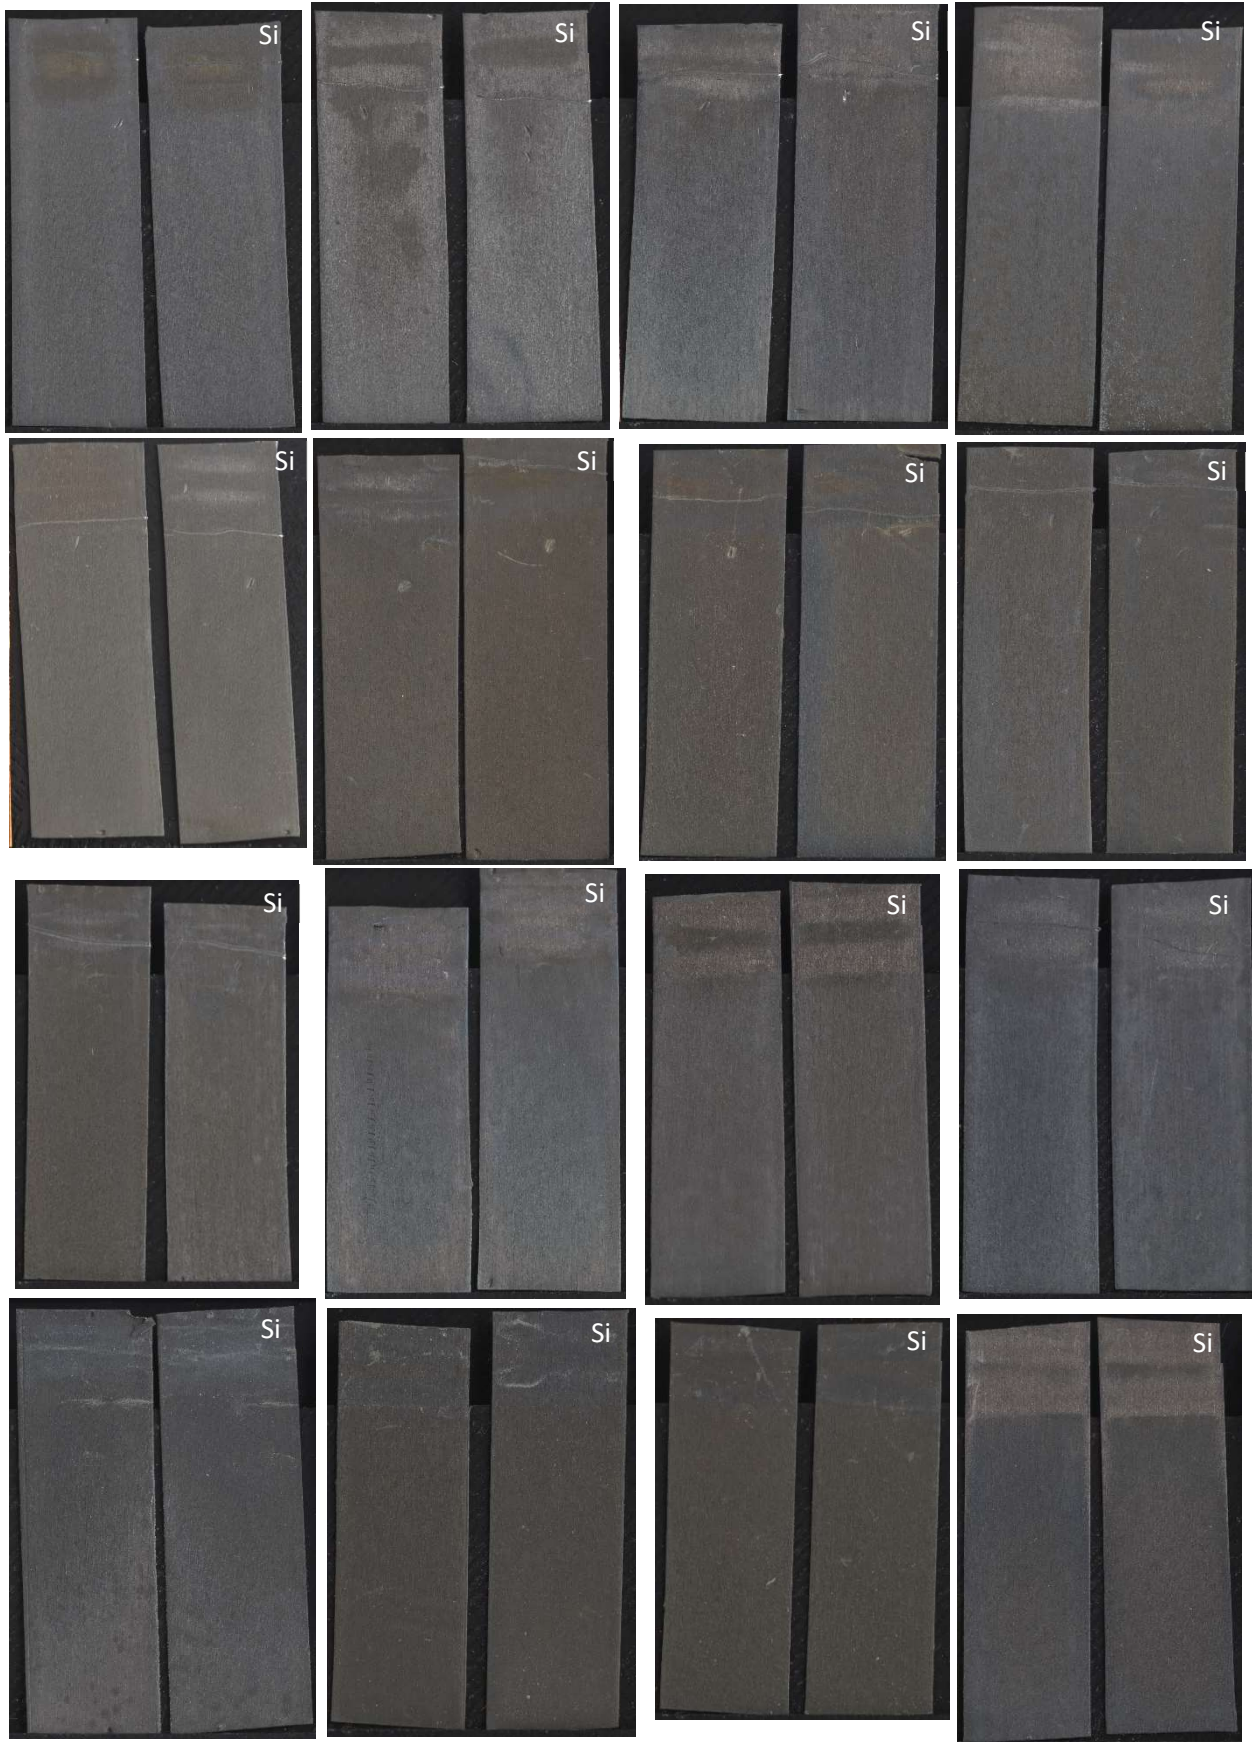
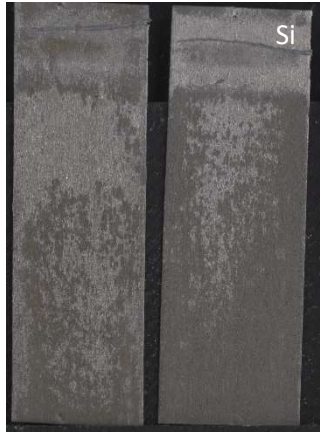
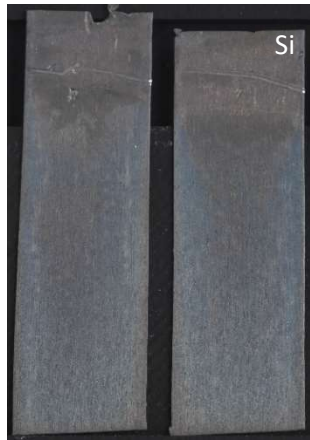
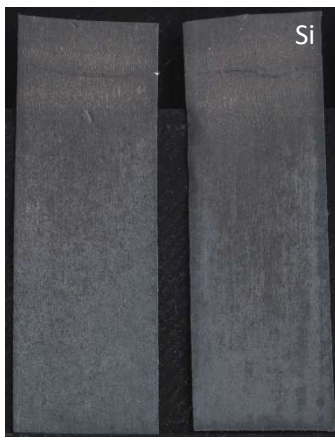
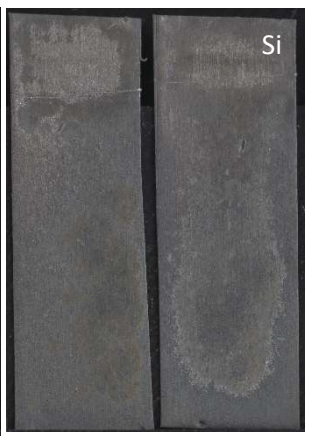
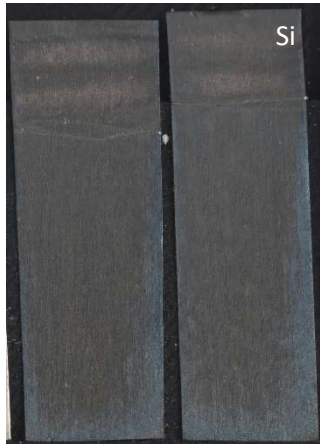
Temporary

“Temporary” rating: The material is safe for use near but not in contact with art for up to six months.

- Lead: darkening, yellow/olive tarnish, haze from slight crystal formation over the entire coupon, or heavier crystal formation at the interface with the coupon holder.

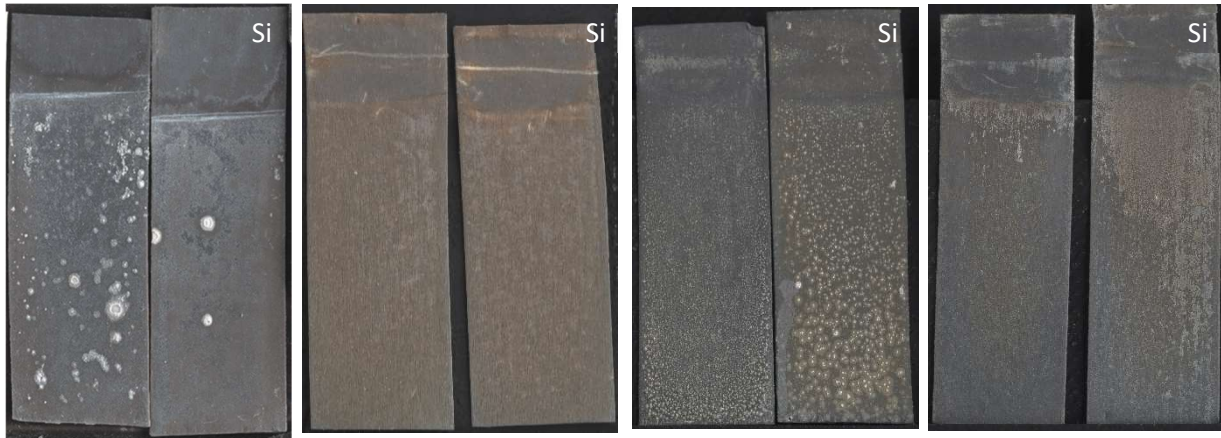
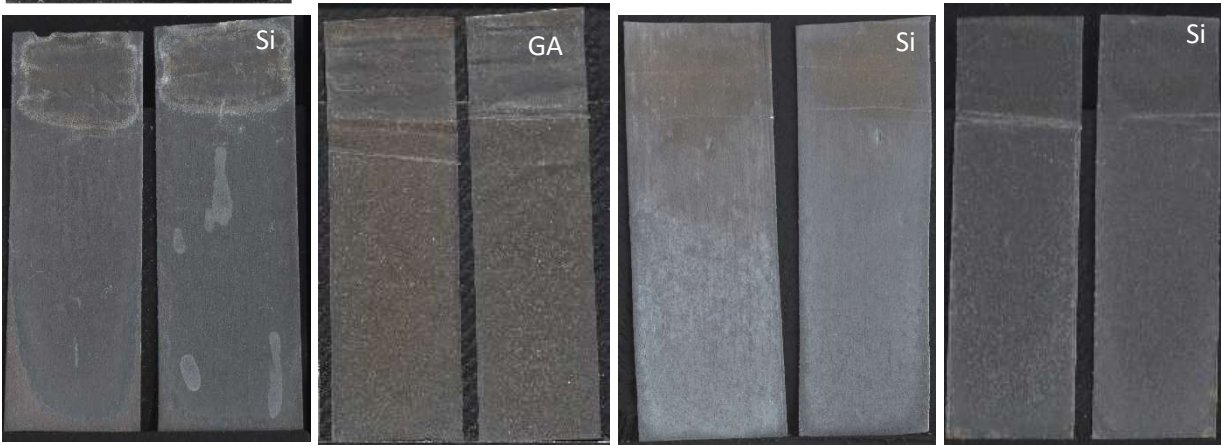
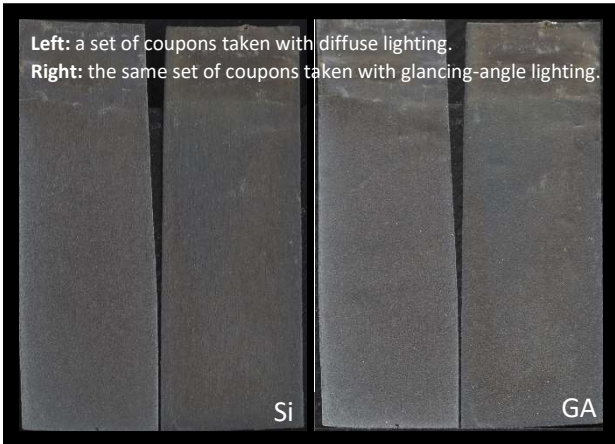
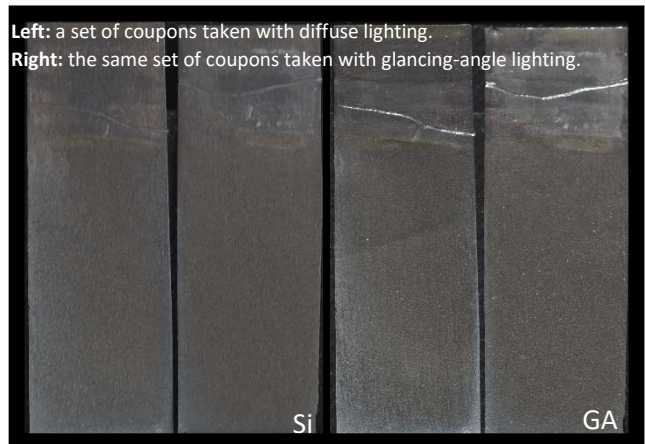
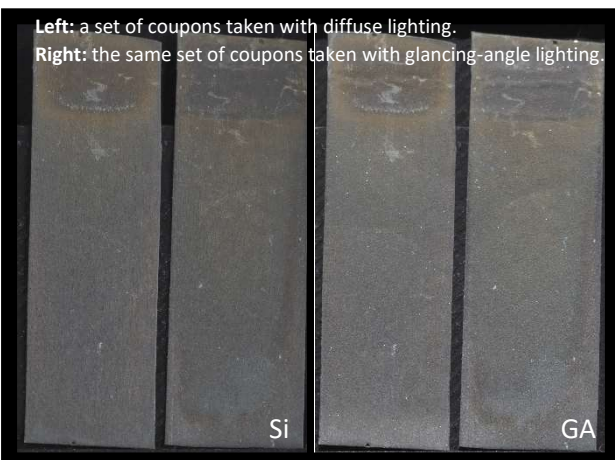
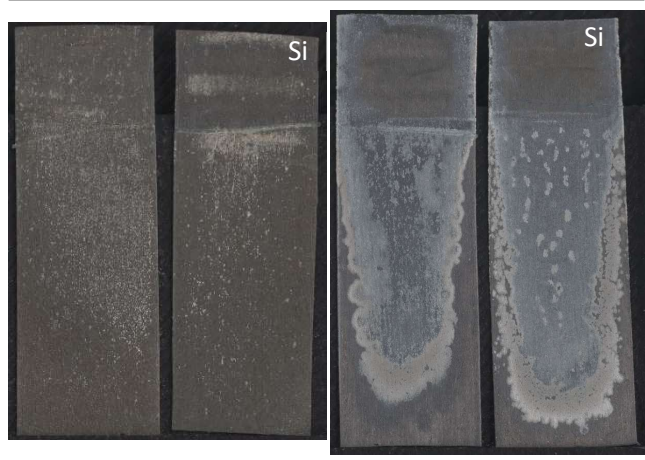
Unsuitable

“Unsuitable” rating: The material should not be used in contact with or near art and another material should be found.

- Lead: white fluffy crystal formation.
